Rehabilitation Approach to Depot Creek

From Headwater to Boulter Road

Rehabilitation Approach to Depot Creek: Headwaters to Boulter Road

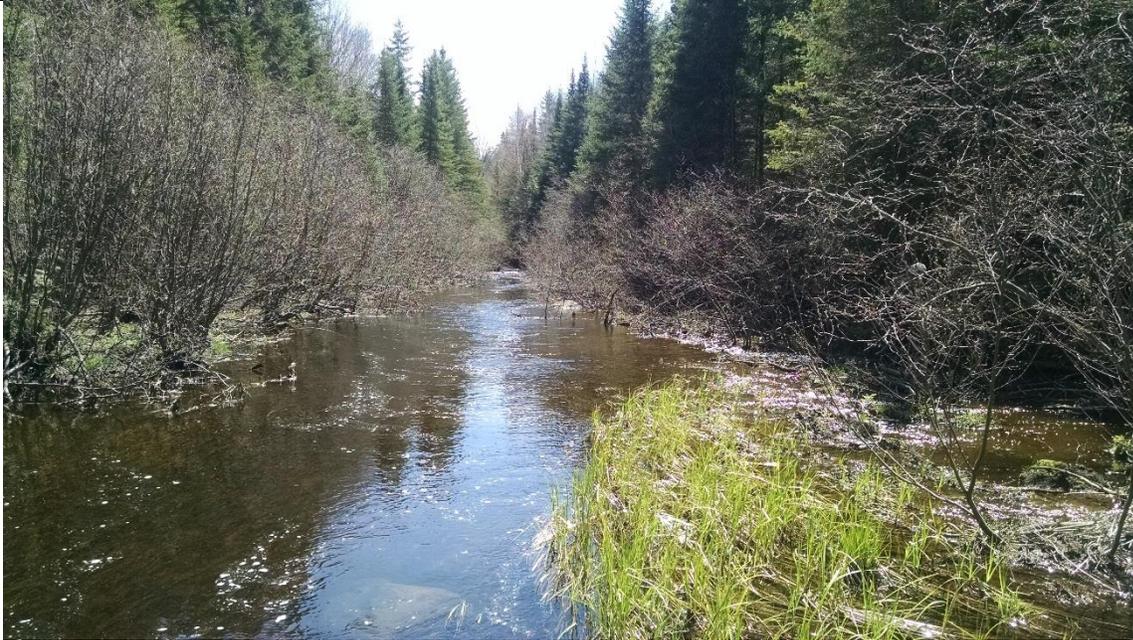
This 1.8 km section from the headwaters to Boulter Road begins with a relatively steep gradient watercourse consisting of fast-moving run/riffle that runs straight for approximately 700 m (photos 1 & 2).

Photos 1 and 2. Fast-moving, alder-lined section, boulder-cobble rapids (first 700 m)

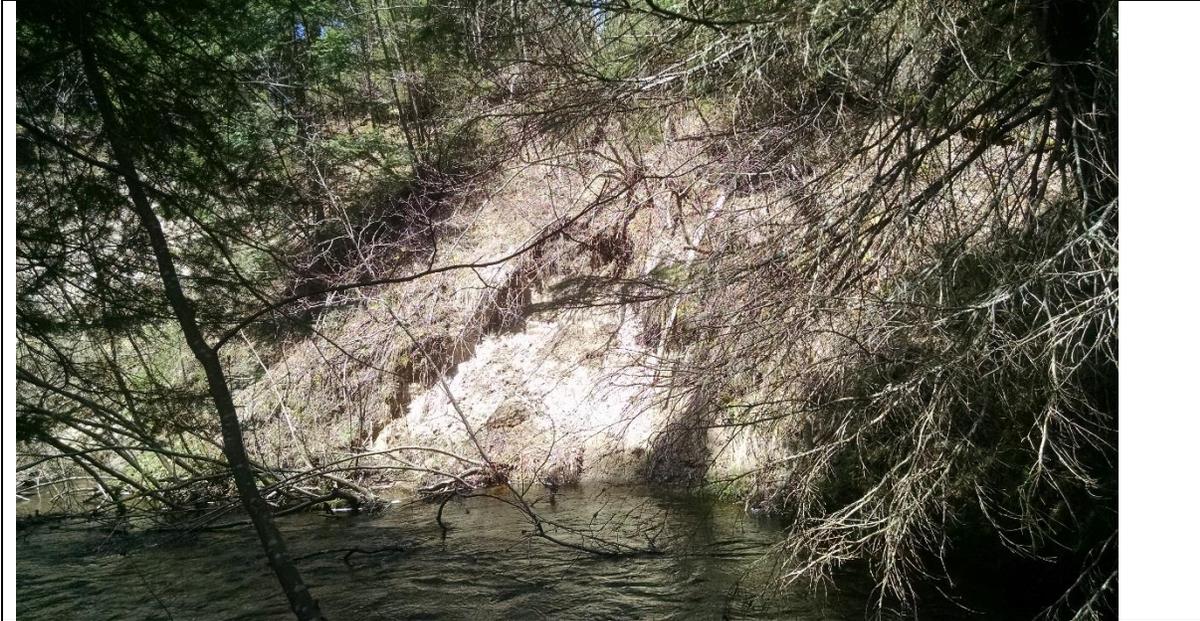
The gradient flattens considerably at the first large meander, where high, steep, exposed sandy banks become prominent (Photo 3).

Photo 3. Typical sand banks and meander for 550 m after gradient flattens

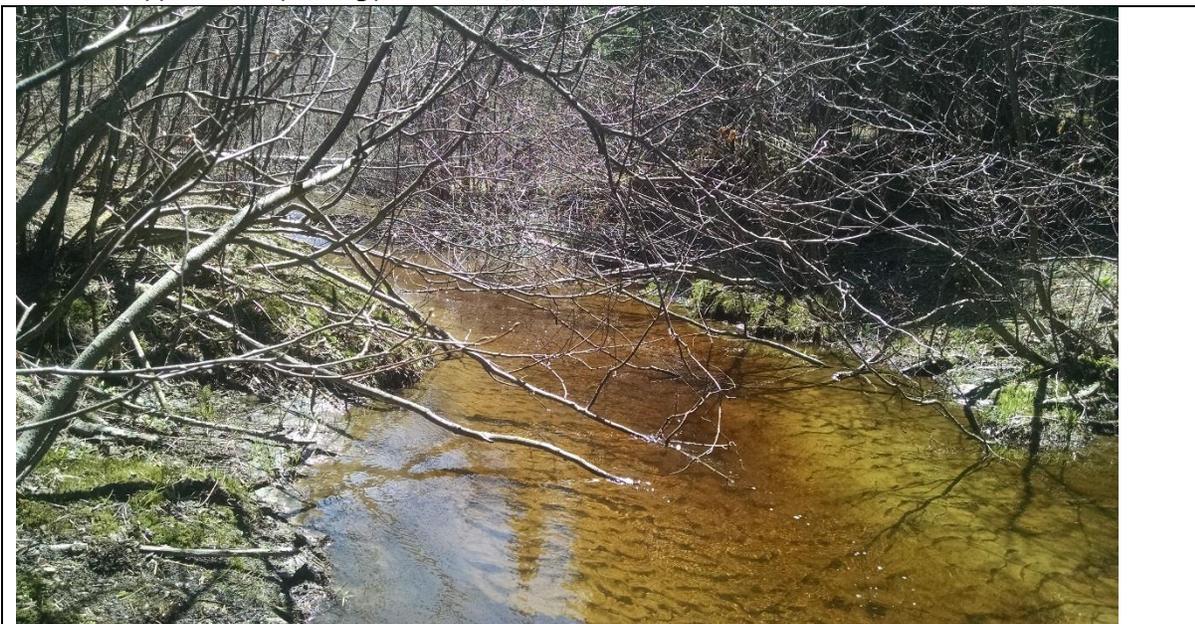
The creek continues to slow and the meanders continue, forming a sand-bottomed, slow, run-pool morphology that continues to Boulter Road for the last 550 m (Photo 4).

Photo 4. Typical morphology for final 550 m to Boulter Road

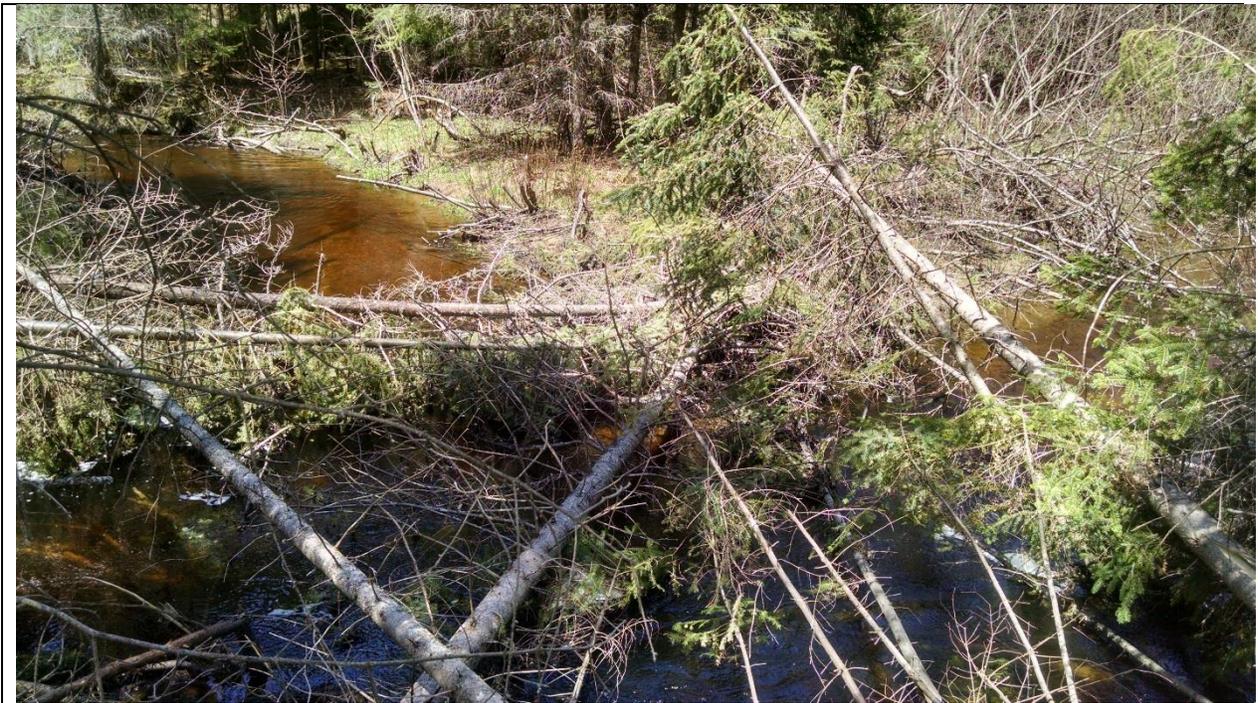
1. Channel obstruction preventing fish passage and diverting stream; leading to additional bank erosion (photo 4);
2. Braided channels reducing flow causing additional sand deposition, alder growth, warmer water temperatures and fish obstruction (photo 5);
3. Alder overgrowth reducing flow, causing additional sand deposition, and reducing stream productivity (photo 6)

Photo 4. Channel Obstruction

- Starting downstream, cut and remove debris that is not submerged, and stockpile in an accessible area away from the streambank.
- Be careful what you remove. Only remove submerged pieces that are entirely blocking the channel. Pieces that are allowing lots of water flow underneath it are providing habitat.
- On the shore, separate the larger logs from the brush. Cut the logs into lengths that you can transport to other areas and use to stabilize banks. Stockpile logs well away from shore for later use.
- Bundle the brush using small gauge wire and a set of pliers, or wrap in burlap. Stockpile well away from shore for later use.

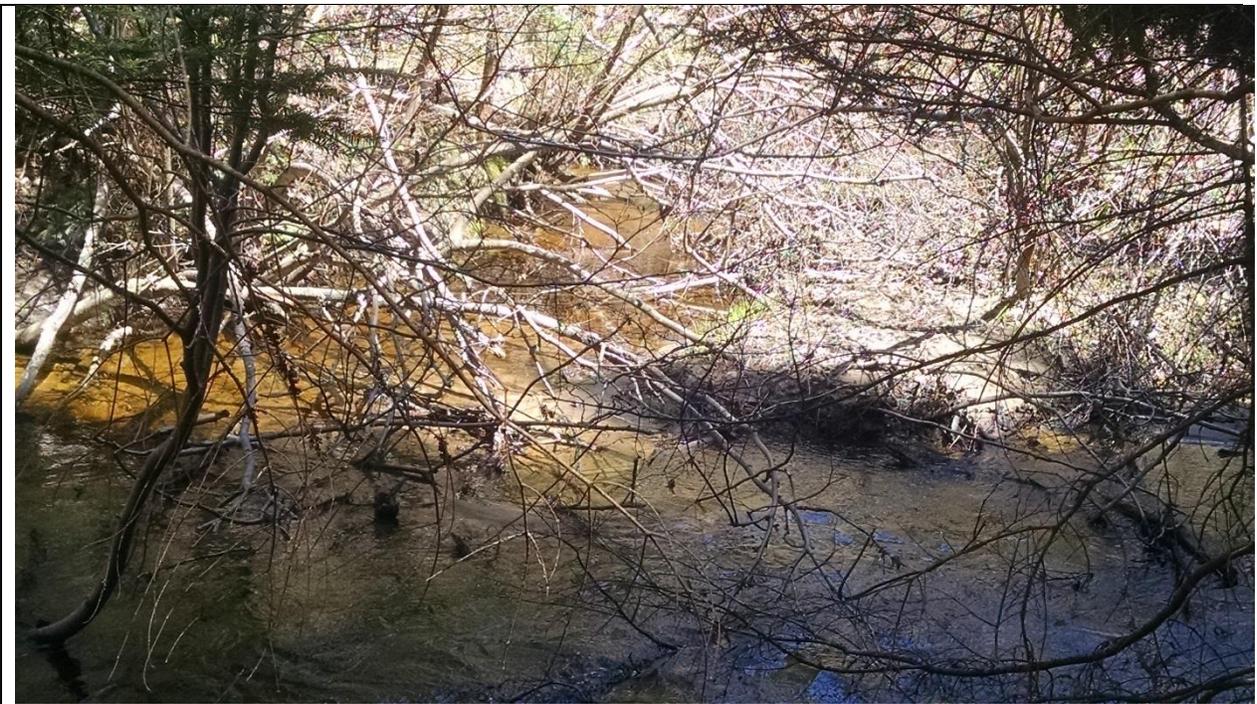
Photo 6. Alder Overgrowth

Cutting back the alders will encourage new growth of dense shoots and a fibrous network of roots to develop. The new root system will provide added anchoring strength to the stream bank. Grasses should also regenerate on the stream bank, and the combination of grasses and bushy new shrub growth will provide improved stream bank cover for fish.

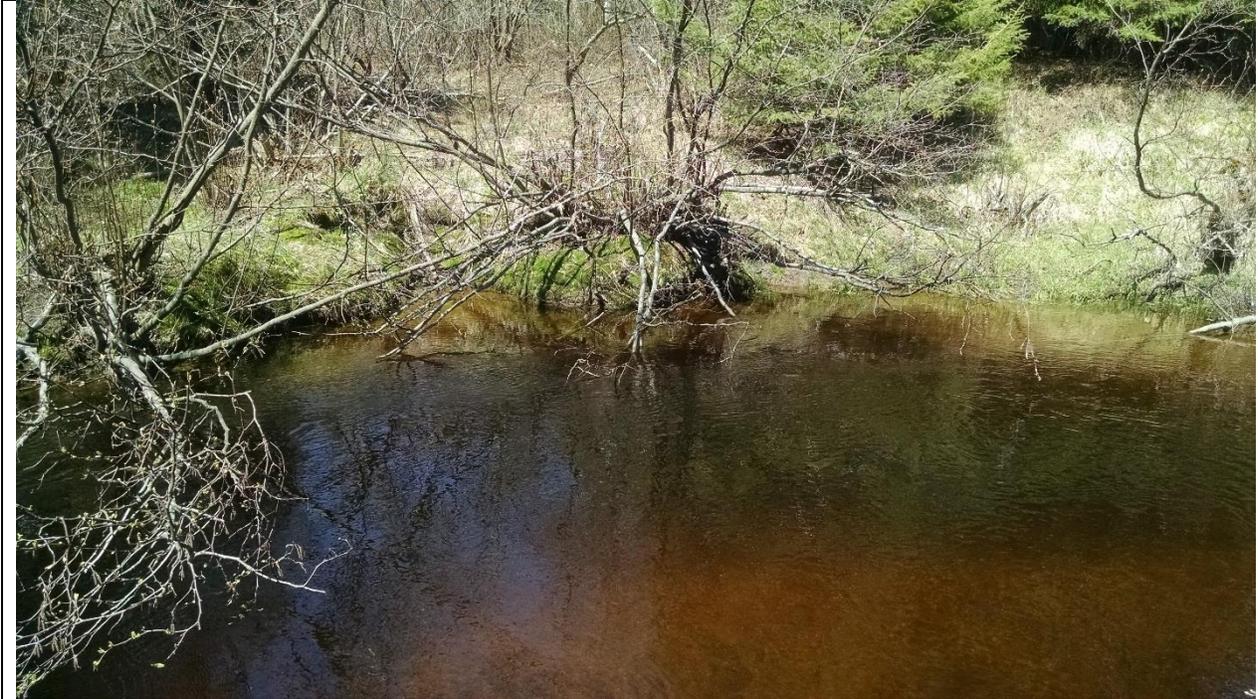
While many small pools exist within this reach that could support larger trout, very little cover habitat exists within these, making habitat quality within these pools marginal (Photo 7).

Photo 7. Typical small, deep pool with minimal cover to support larger trout.

It is recommended that instream cover structures be built into the bank; as the banks are relatively easy to key into and will prevent the structure from becoming embedded in sand.

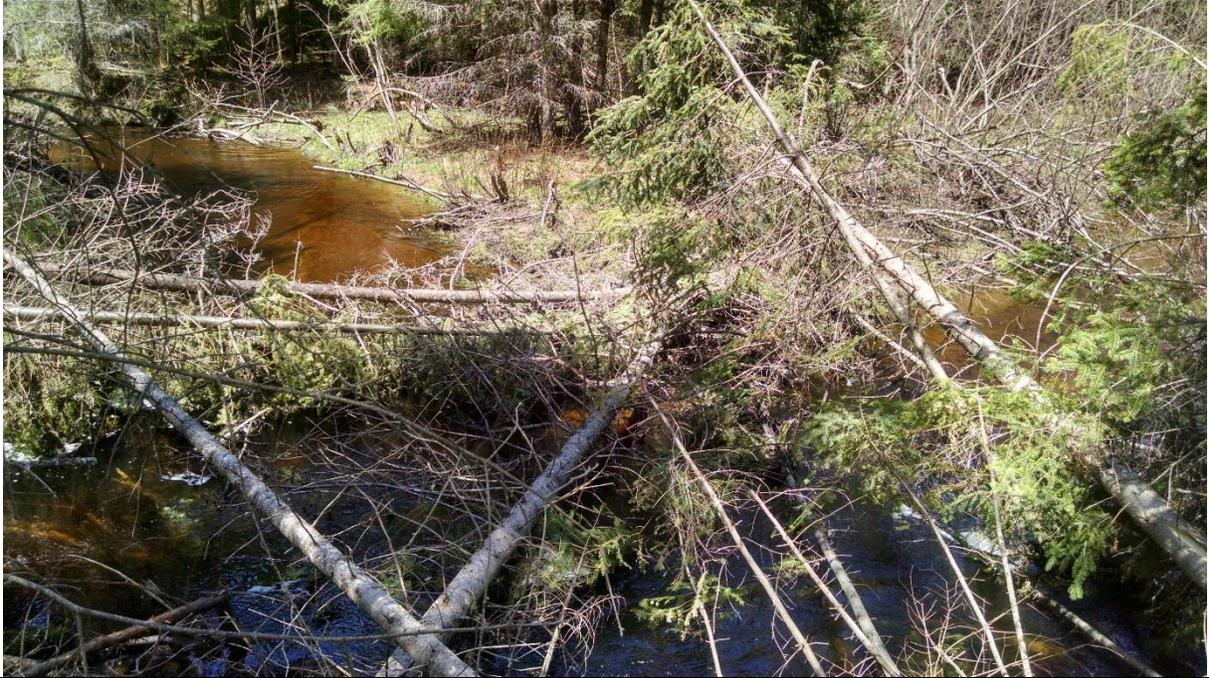
17T 647608 5109103

Rehabilitation Action 1. Remove Channel Obstructions

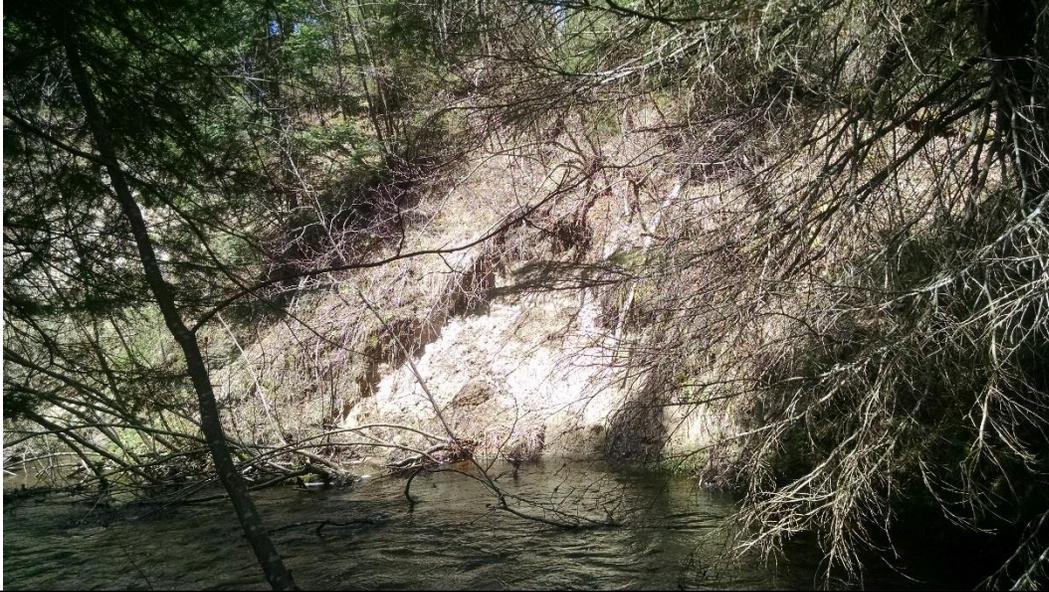
17T 647610 5109216

Rehabilitation Action 2: Stabilize Major Erosion Areas

- Brush bundles by themselves can be keyed into the exposed bank to prevent further erosion, as well as capture sand and soil which will eventually allow vegetation to colonize and permanently stabilize the bank:

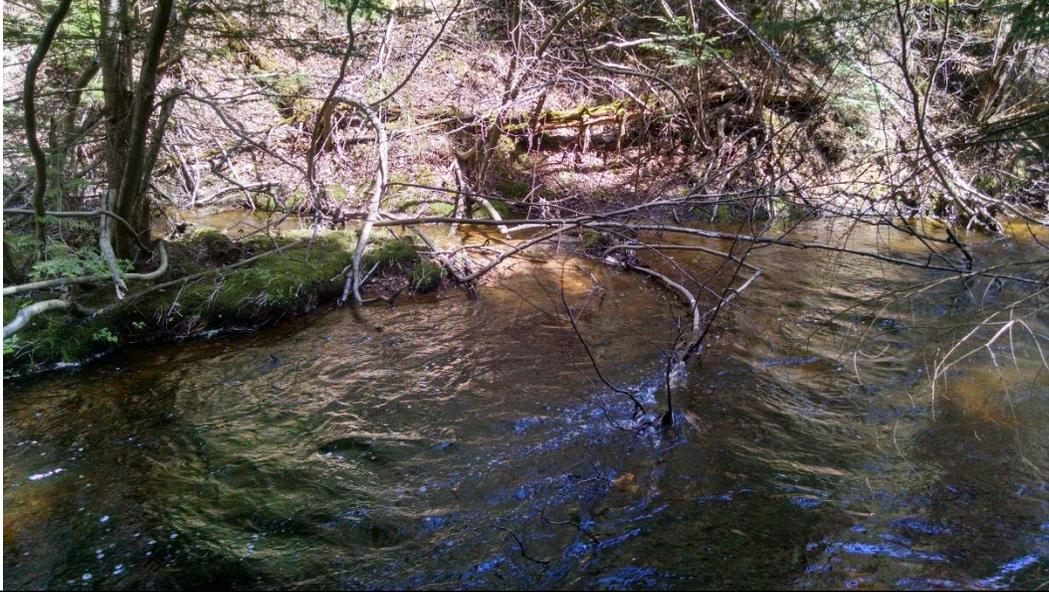
17T 647654 5109212

Rehabilitation Action 3: Deflect Flow back to Main Channel

The objective in this case is to concentrate flow and develop a narrower, deeper channel, thereby eliminating many of the channel braids that have formed. One technique that is most appropriate for this case is the use of log deflectors. The intent of the log deflectors in this case, is to divert stream flow away from the braids in the channel and back into the main stream flow. The desired outcome is:

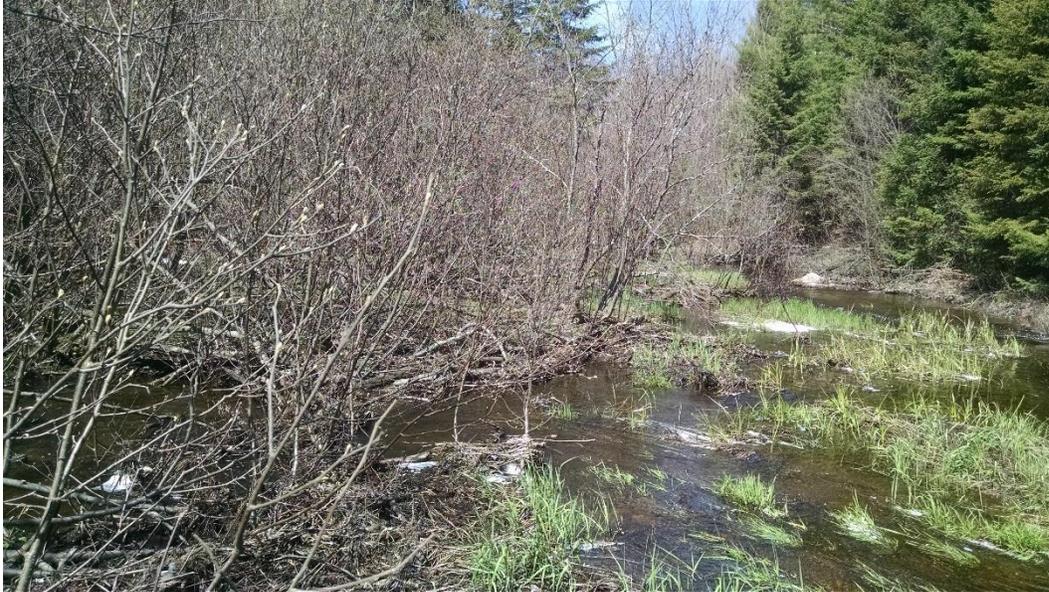
17T 648095 5108984

Rehabilitation Action 4. Cut Back Areas of Overgrown Alders

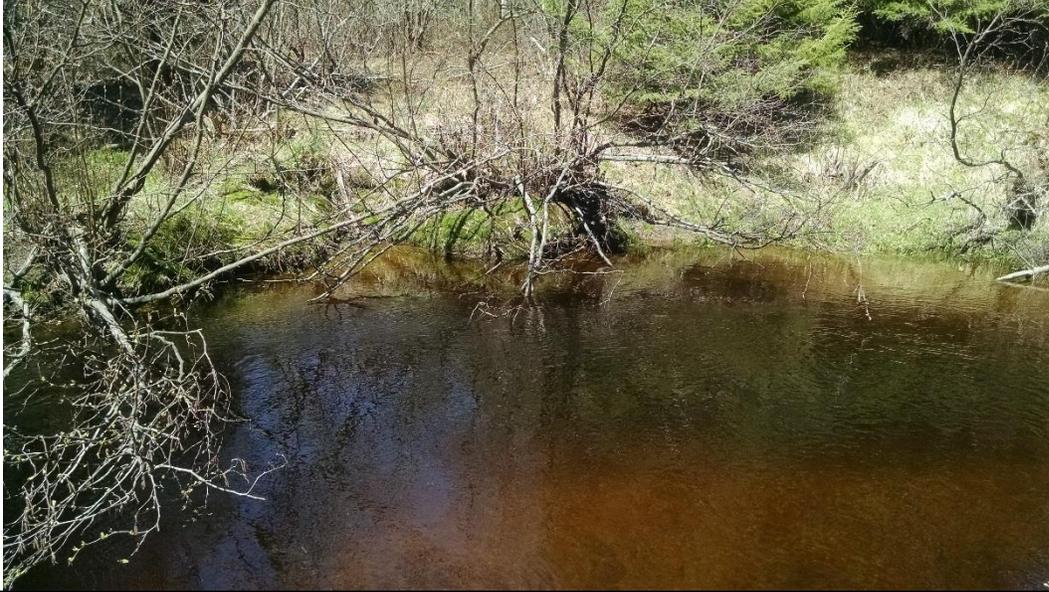
17T 646743 5109170

These pools have high sand banks and a sand bottom. Placing any structure on the stream bottom will not likely be effective, as the moving sand bedload, which is a natural feature of this watercourse, will eventually cover it up.

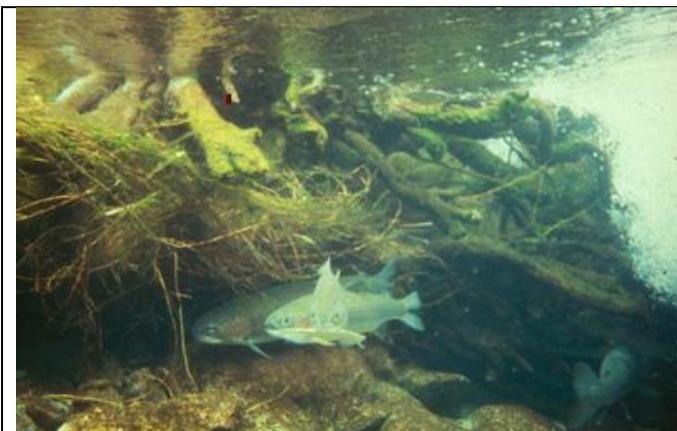
There are many options for building structures that will attract adult trout. The key is to provide overhead cover to fish in the deepest pools available.

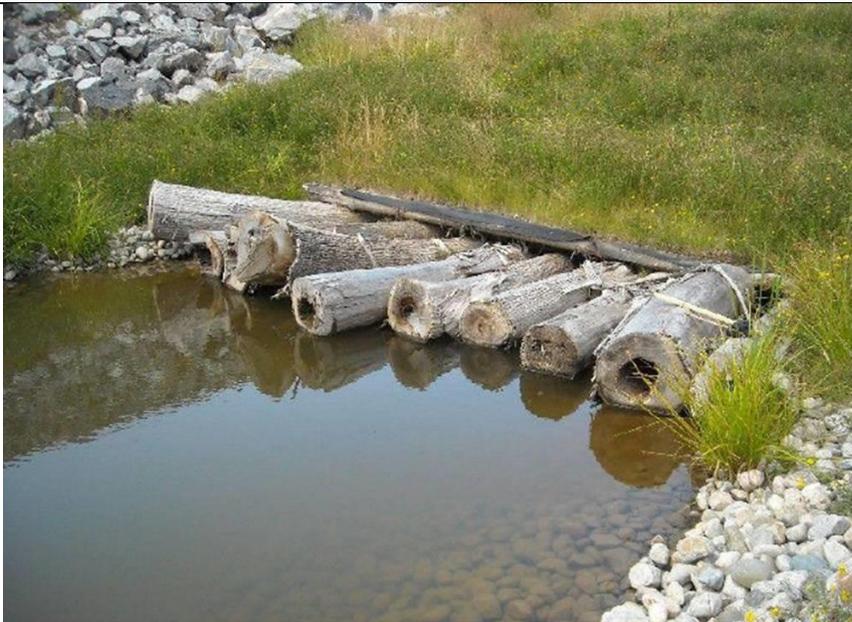
Some typical designs follow.
